**National Highway  
Traffic Safety  
Administration**

Case Vehicle (A): 1999 Pontiac  
 Type: Grand Am, 2-door coupe  
 Driver: 28-year-old male  
 CDC: 12-FREN-5, 12-LDES-2

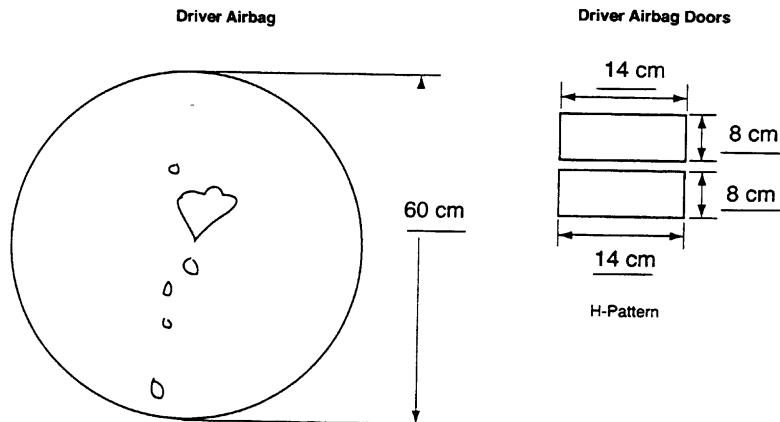
## AIRBAG NUMBER ON DRIVER SIDE:

NOTE AND DESCRIBE ANY AIRBAG CONTACT OR  
DAMAGE ON DIAGRAM BELOW:

Vents:  Y  N  
if yes, how many: 2

Tethers:  Y  N  
if yes, how many: 2

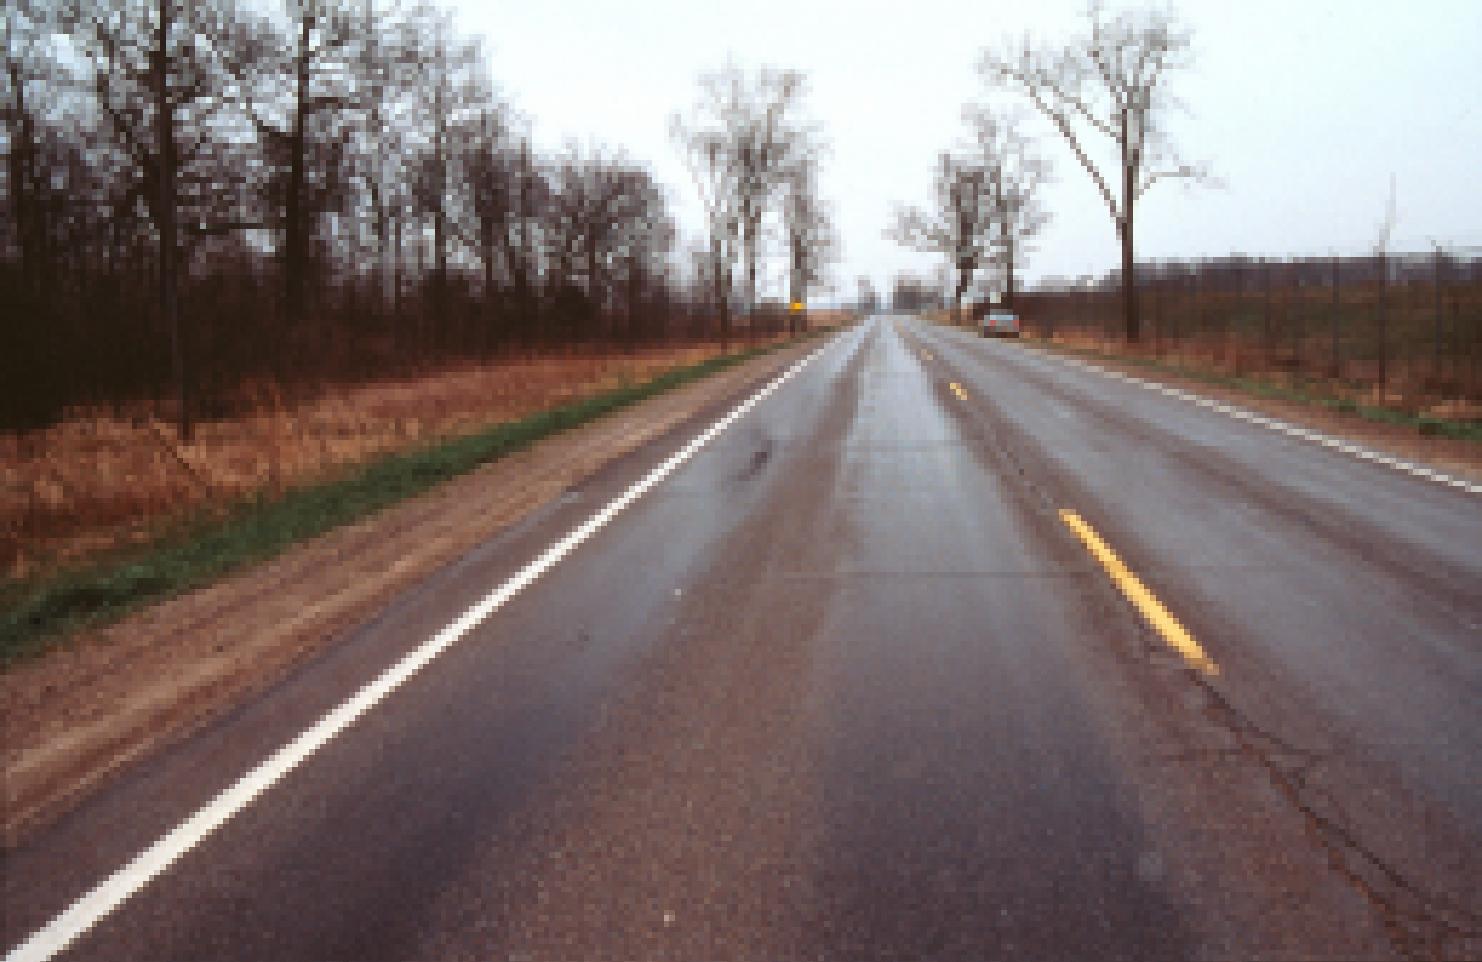
PN 20200 #1

(Slide 1) Case vehicle (A) was traveling south in the southbound lane of a straight section of a dry, asphalt, two-lane roadway, (slides 2, 3) with a speed limit of 89 kph (55 mph). Case vehicle (A) drifted across the centerline, departed the east shoulder of the roadway, and traveled down a shallow embankment. The left side of case vehicle (A) sideswiped a clump of trees before case vehicle (A) struck a tree with its right-front bumper corner. Case vehicle (A) came to rest facing south-southeast. The driver of case vehicle (A) had a blood alcohol level of .16 percent.

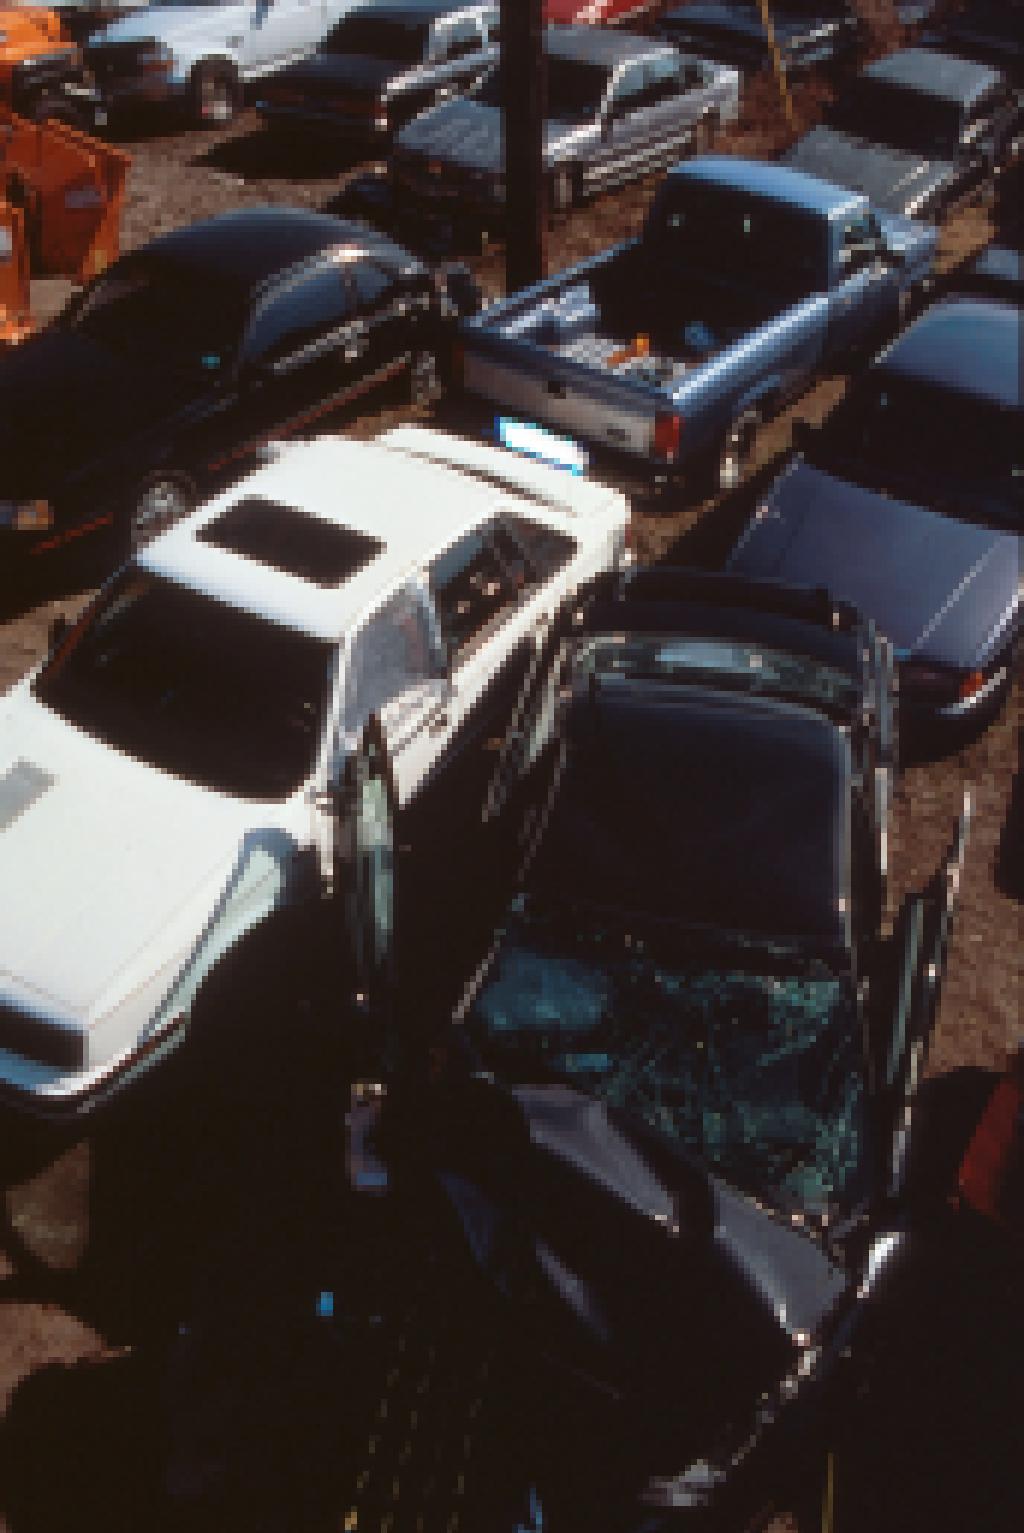
**PN 20200 #4**  
**Best Available**

(Slide 4) Damage to case vehicle (A) was severe. The direct-damage length was 37 cm and began 10-cm in board of the right-front bumper corner. The maximum crush to the bumper was 116 cm and occurred at the right-front bumper corner. The left wheelbase was extended 13 cm, and the right wheelbase was reduced 42 cm. The maximum crush above the sill associated with the sideswipe impact was estimated to be 14 cm.

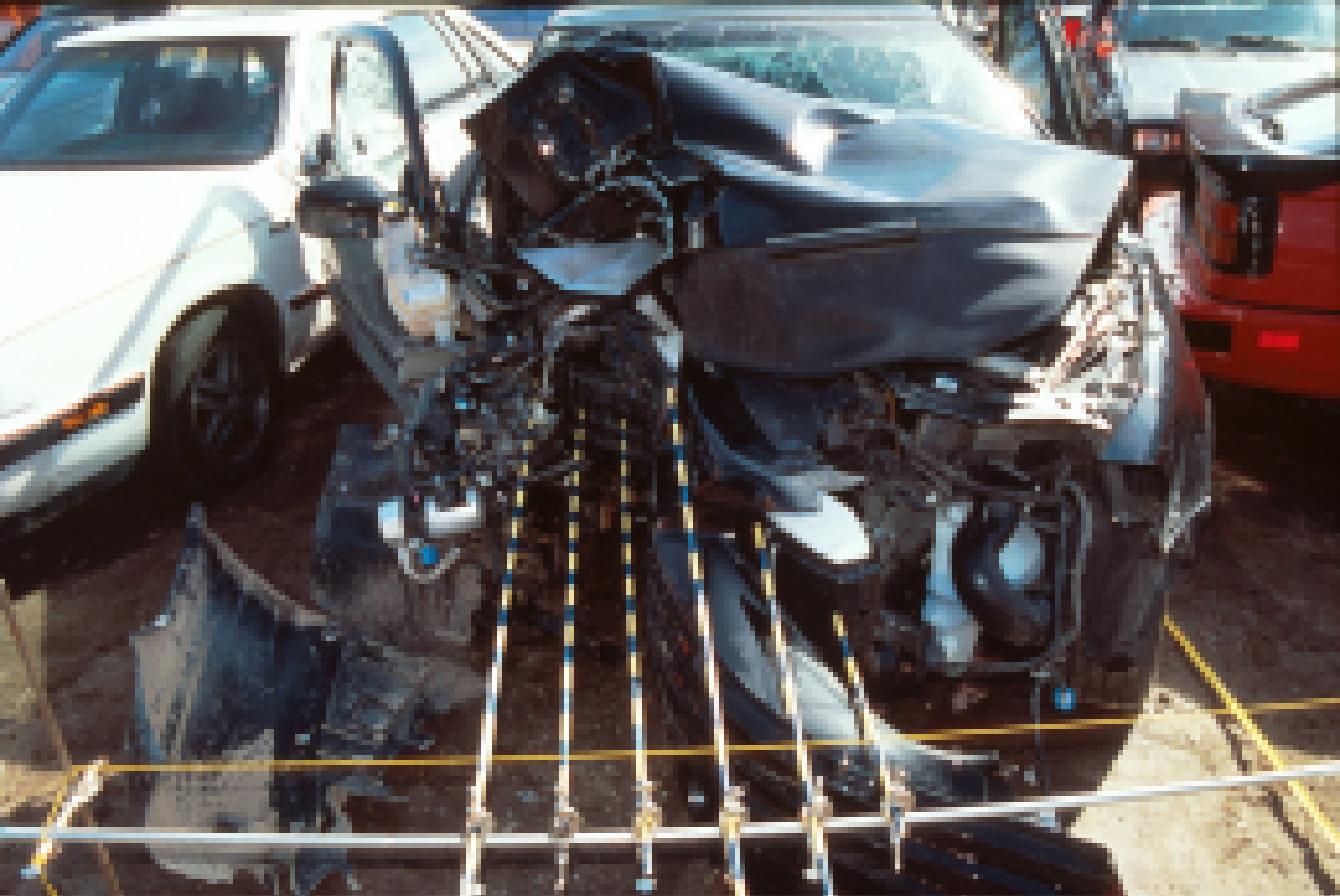
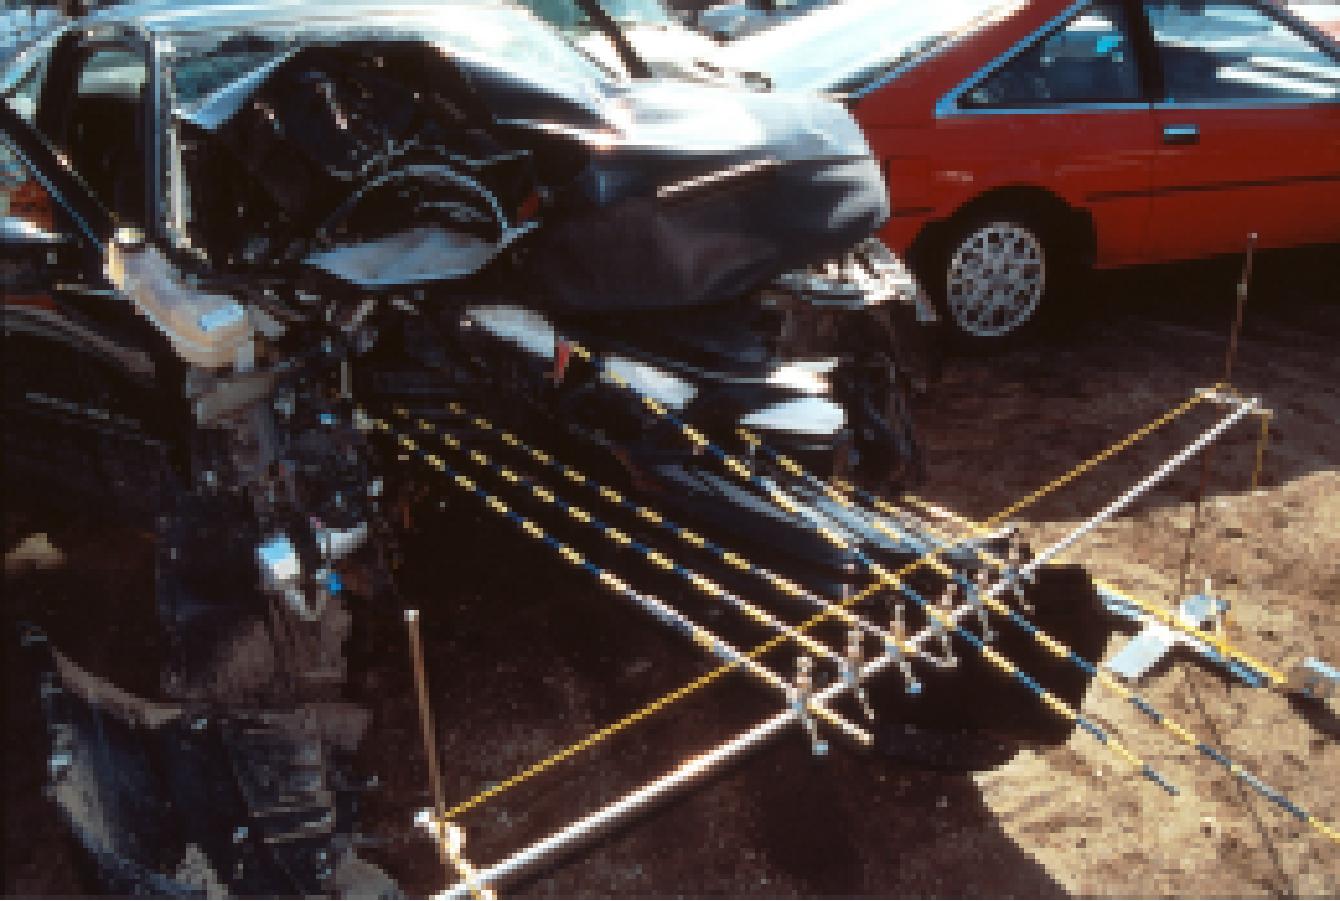
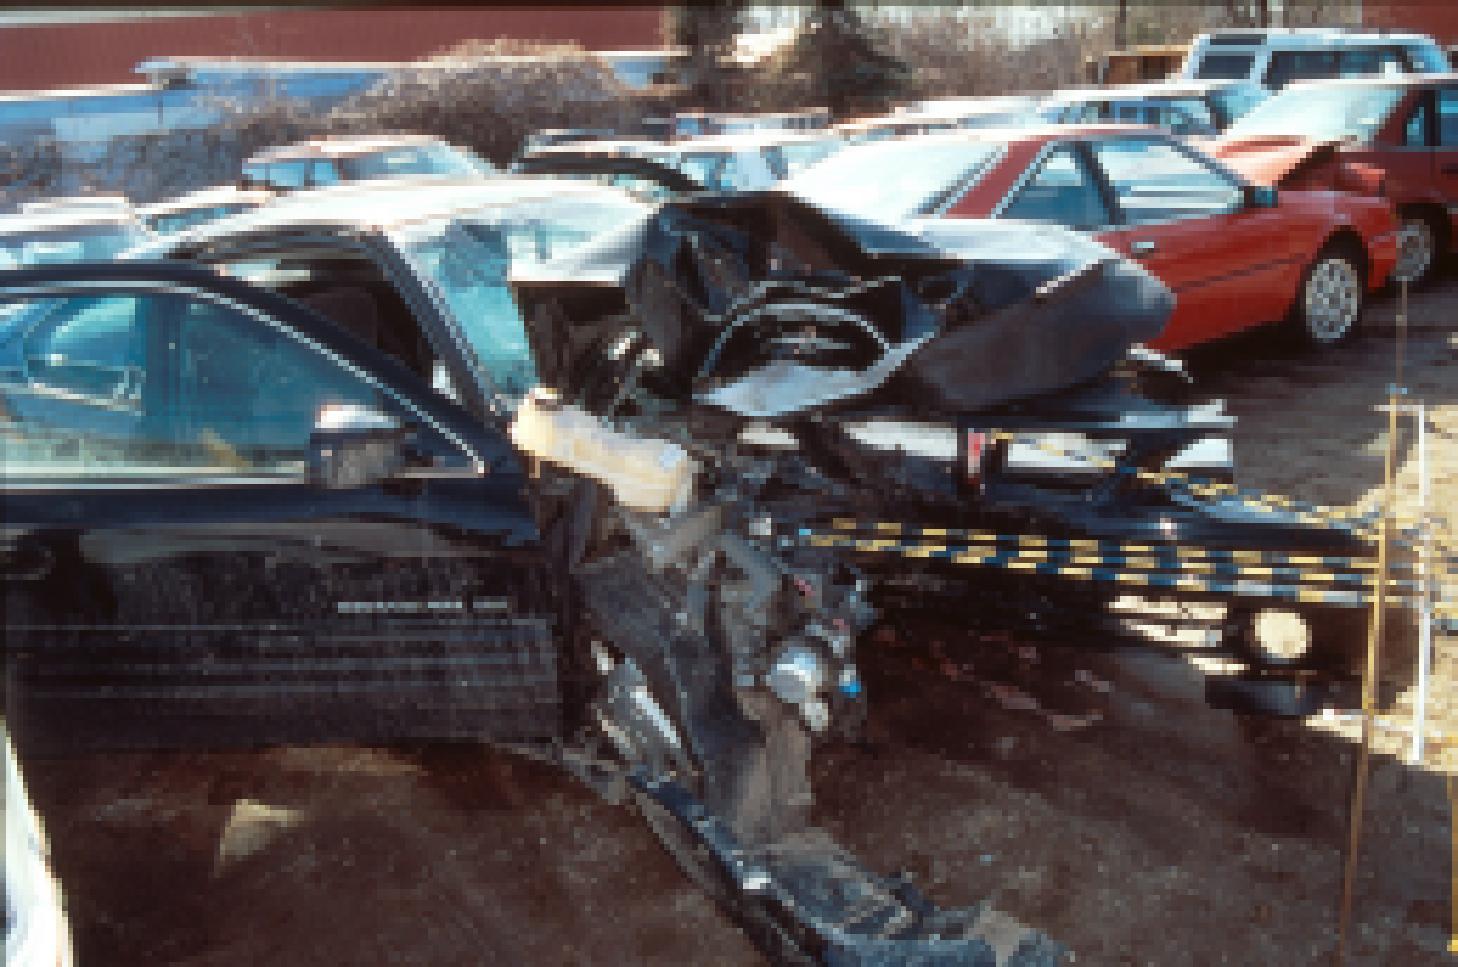
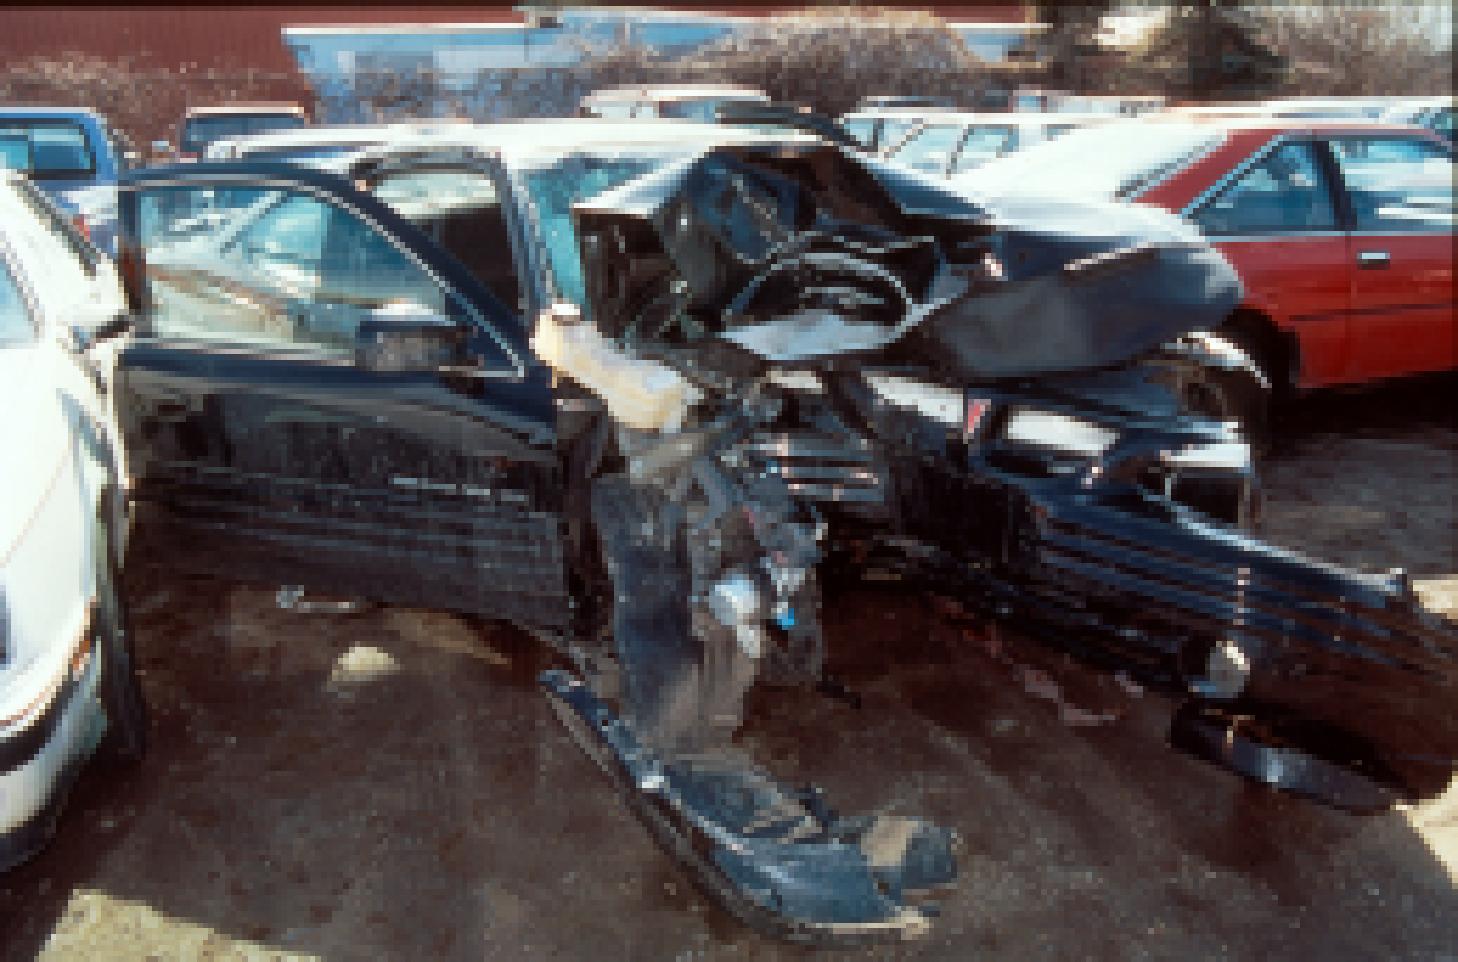
Using the WinSMASH accident-reconstruction program and (slides 5, 6, 7, 8) c-values for case vehicle (A), the following impact severity was calculated:

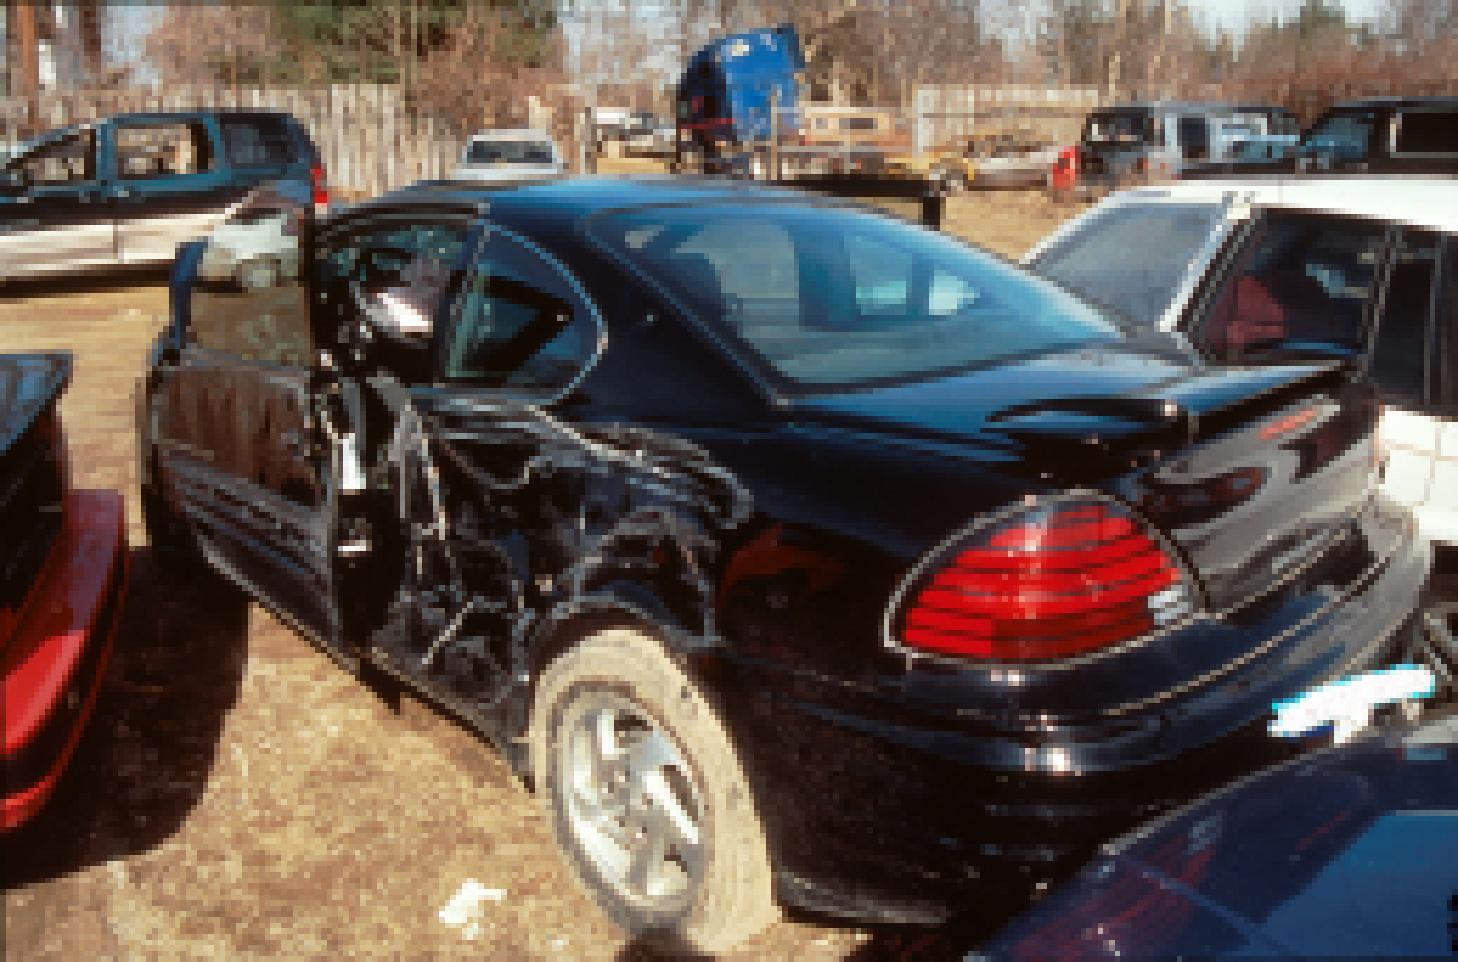
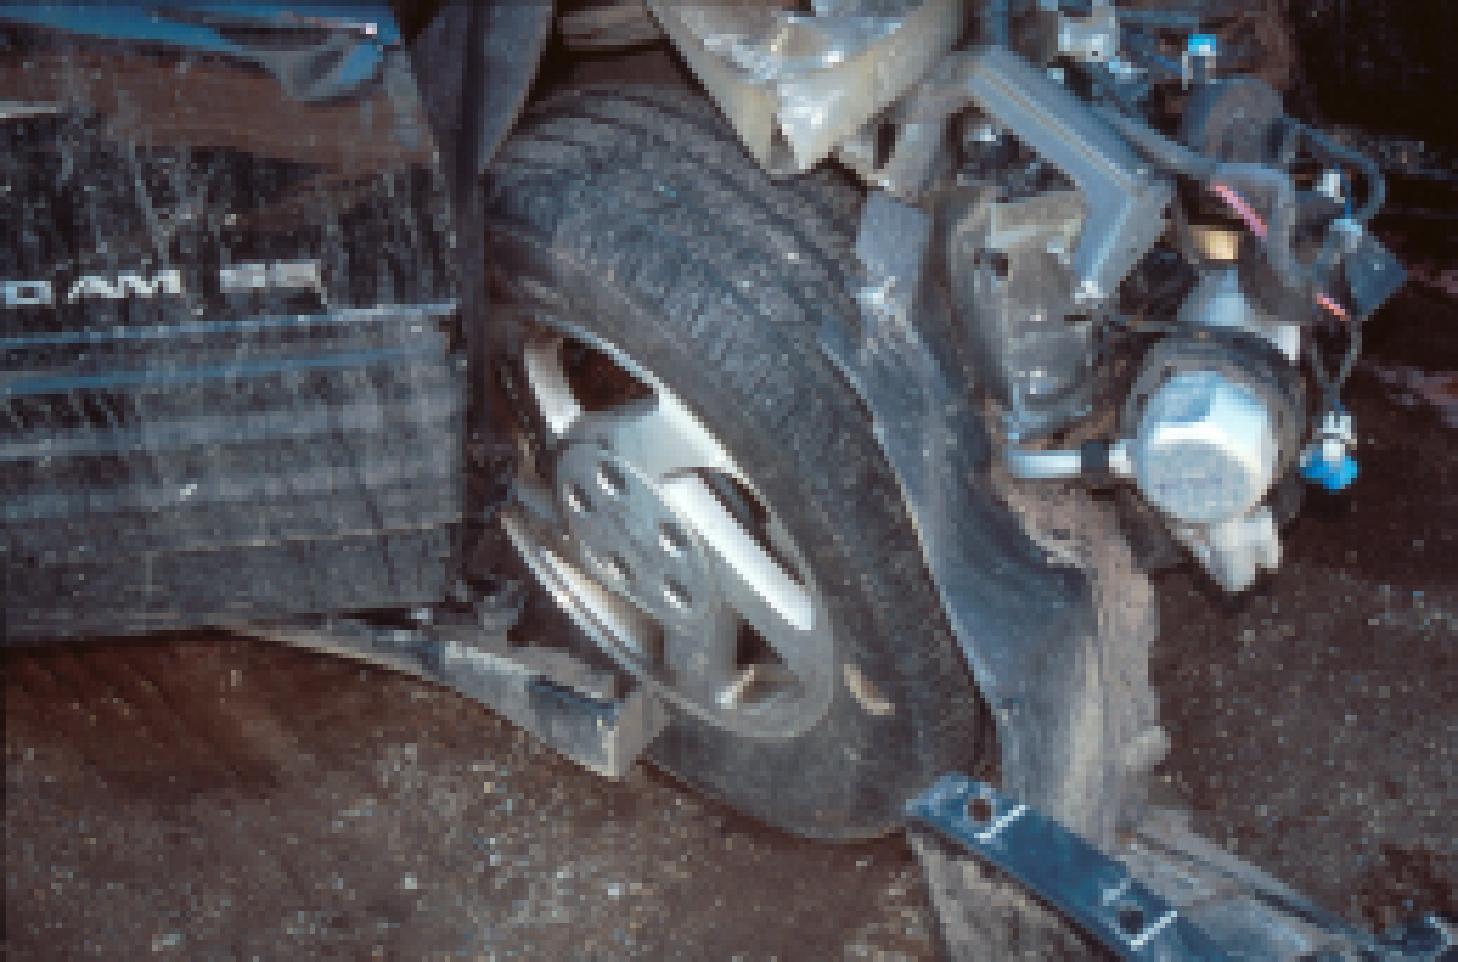
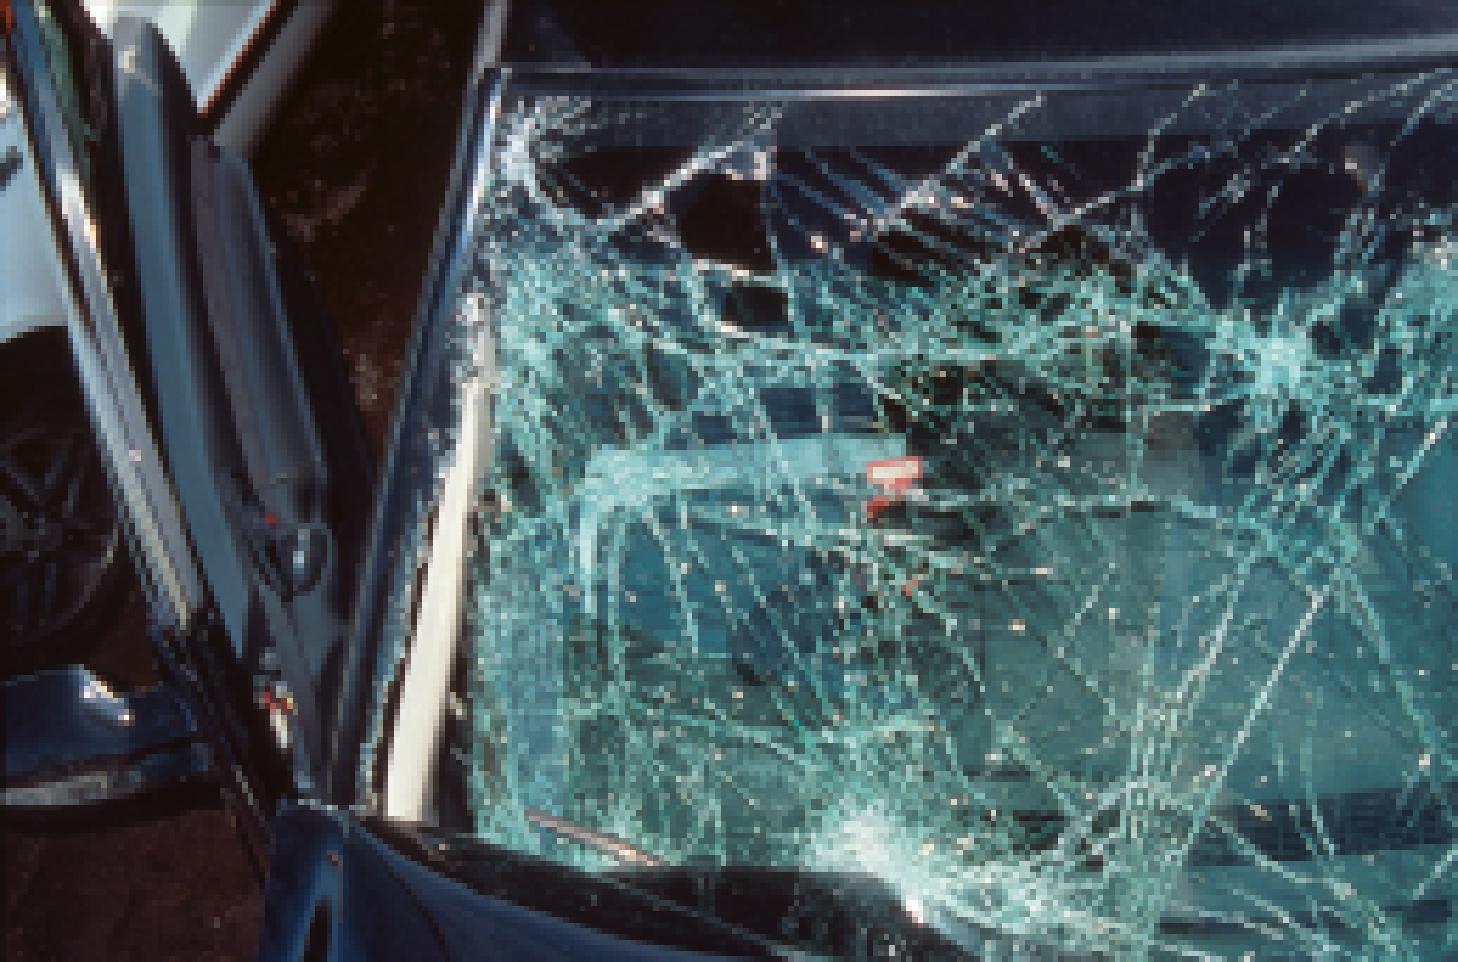
(Slides 9, 10, 11) The front bumper, both headlight assemblies, the grille, the radiator, the right fender, and the right-front wheel and strut were damaged. The hood was crushed, and the hood

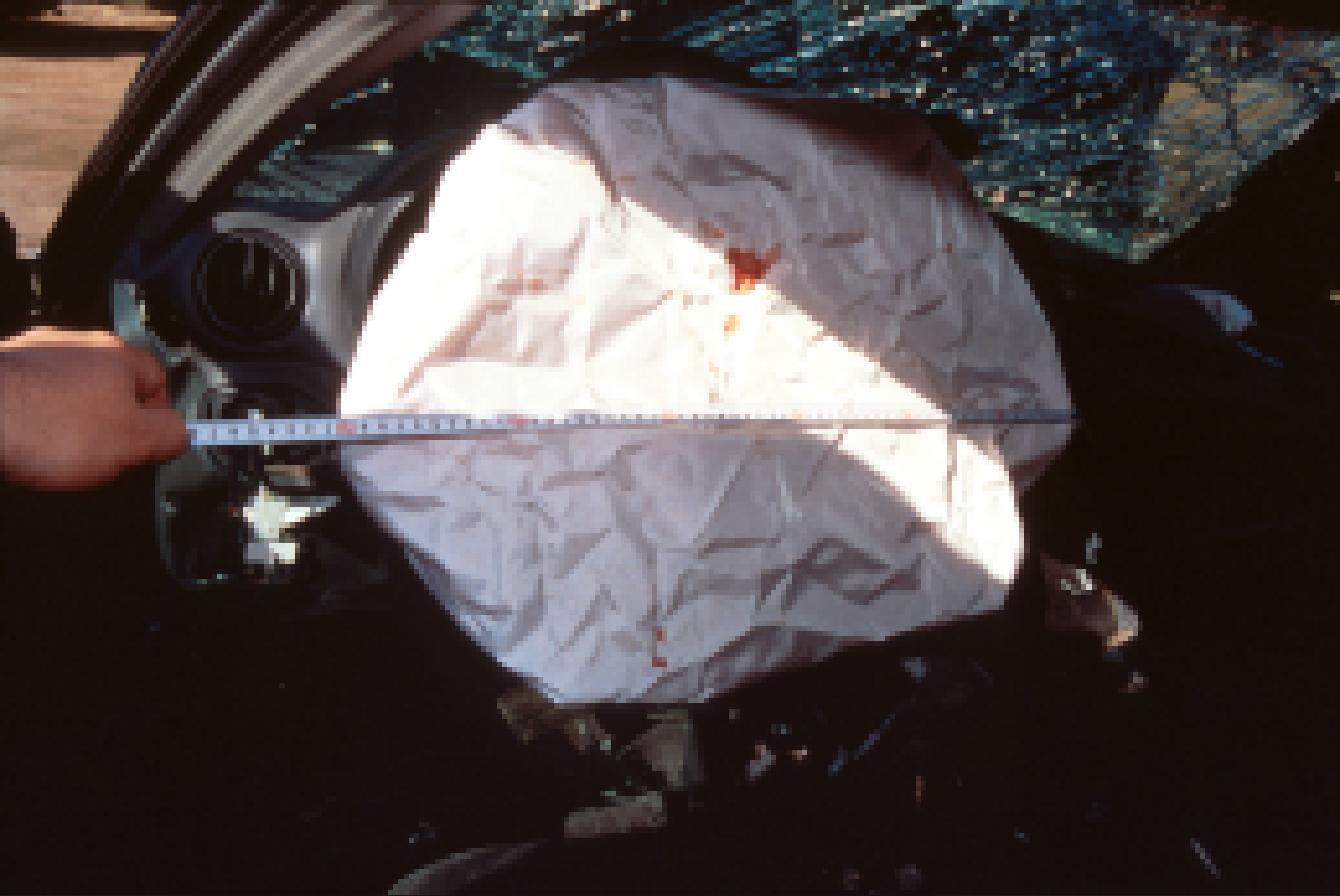
PN 20200412

latch was jammed. Both hood hinges were damaged, but did not separate. The rear edge of the hood was elevated and it contacted the windshield, but did not penetrate it. (Slide 12) The windshield was holed from the bottom right corner up to approximately two-thirds the height of the right A-pillar. Both doors remained closed during the crash, but were sprung and would not close post-crash.

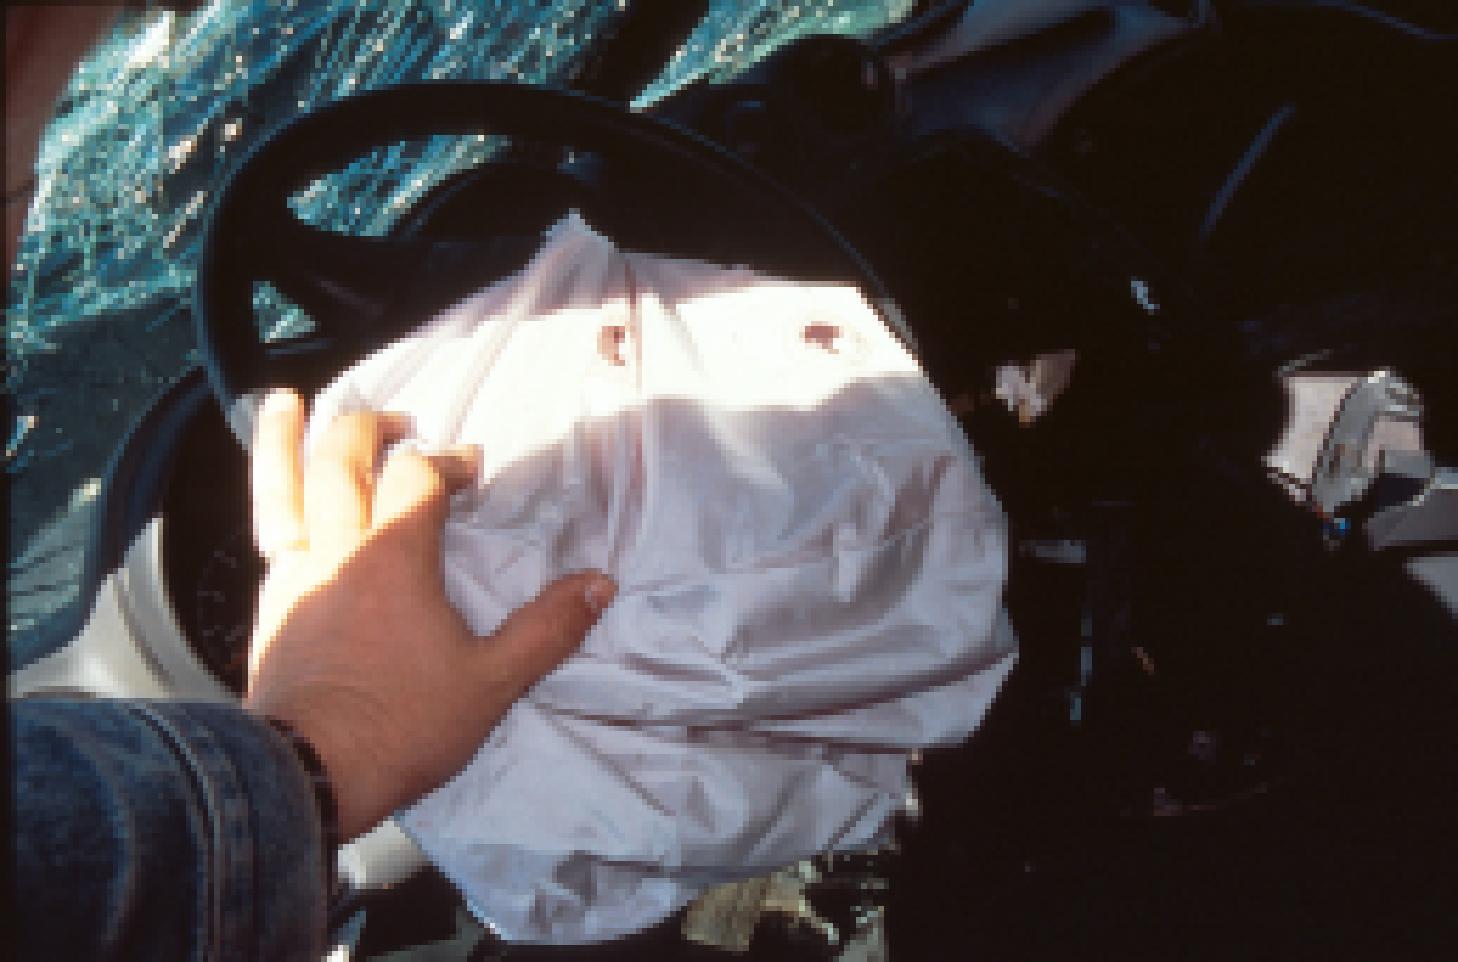
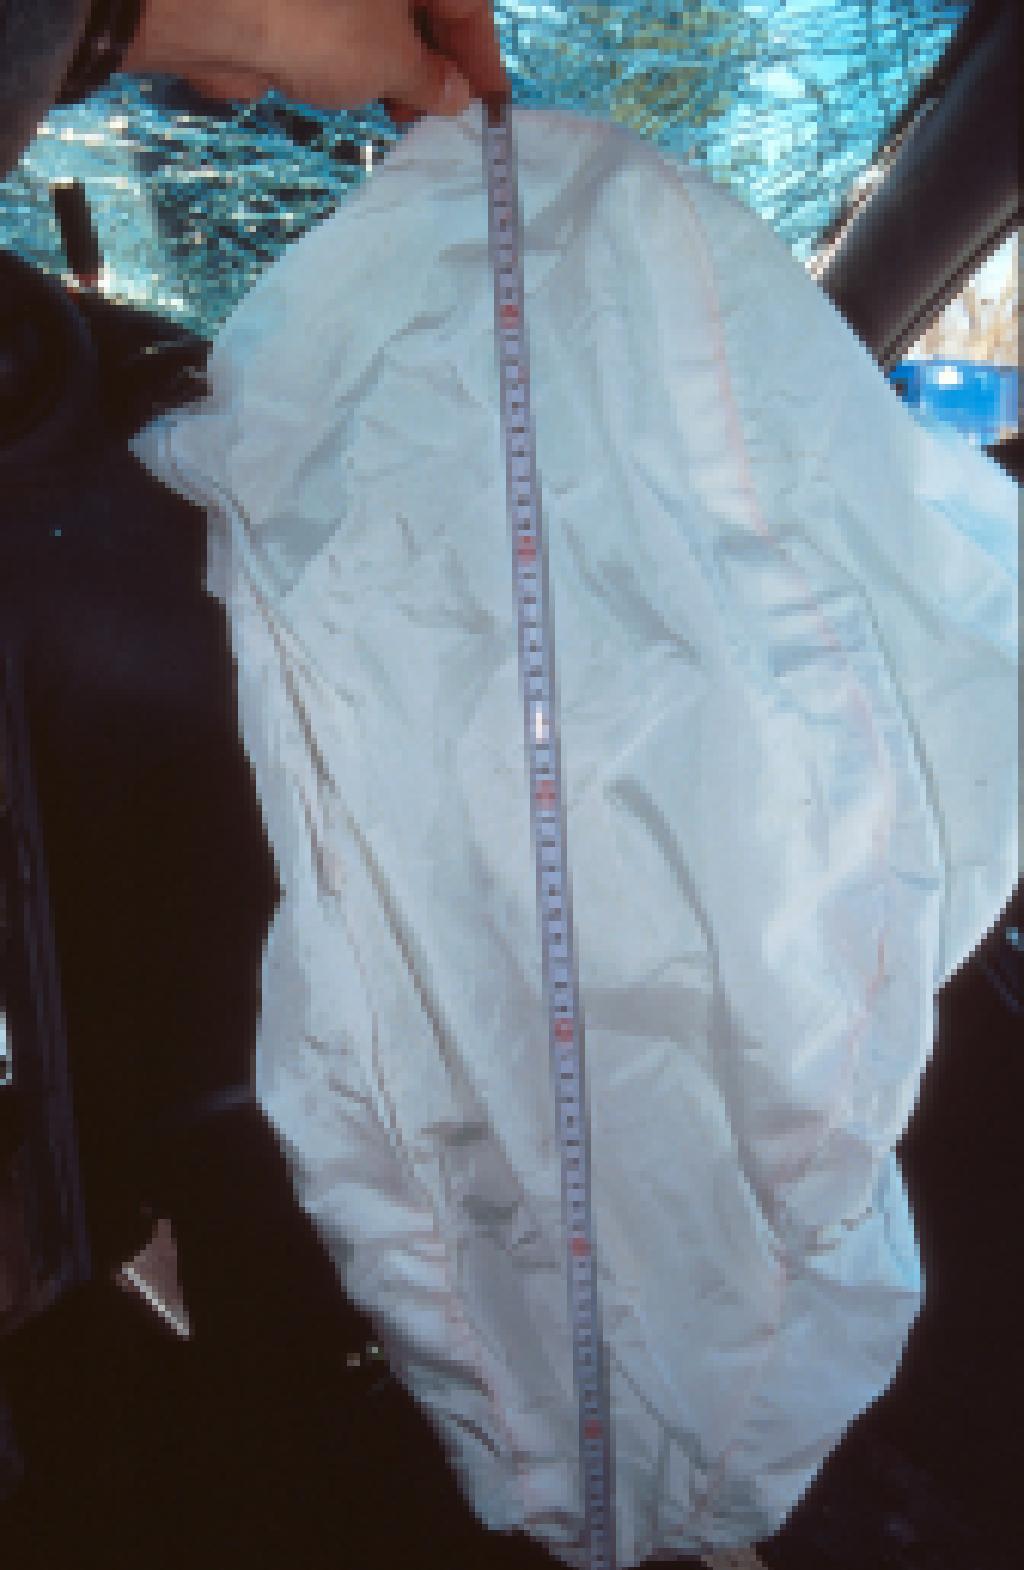
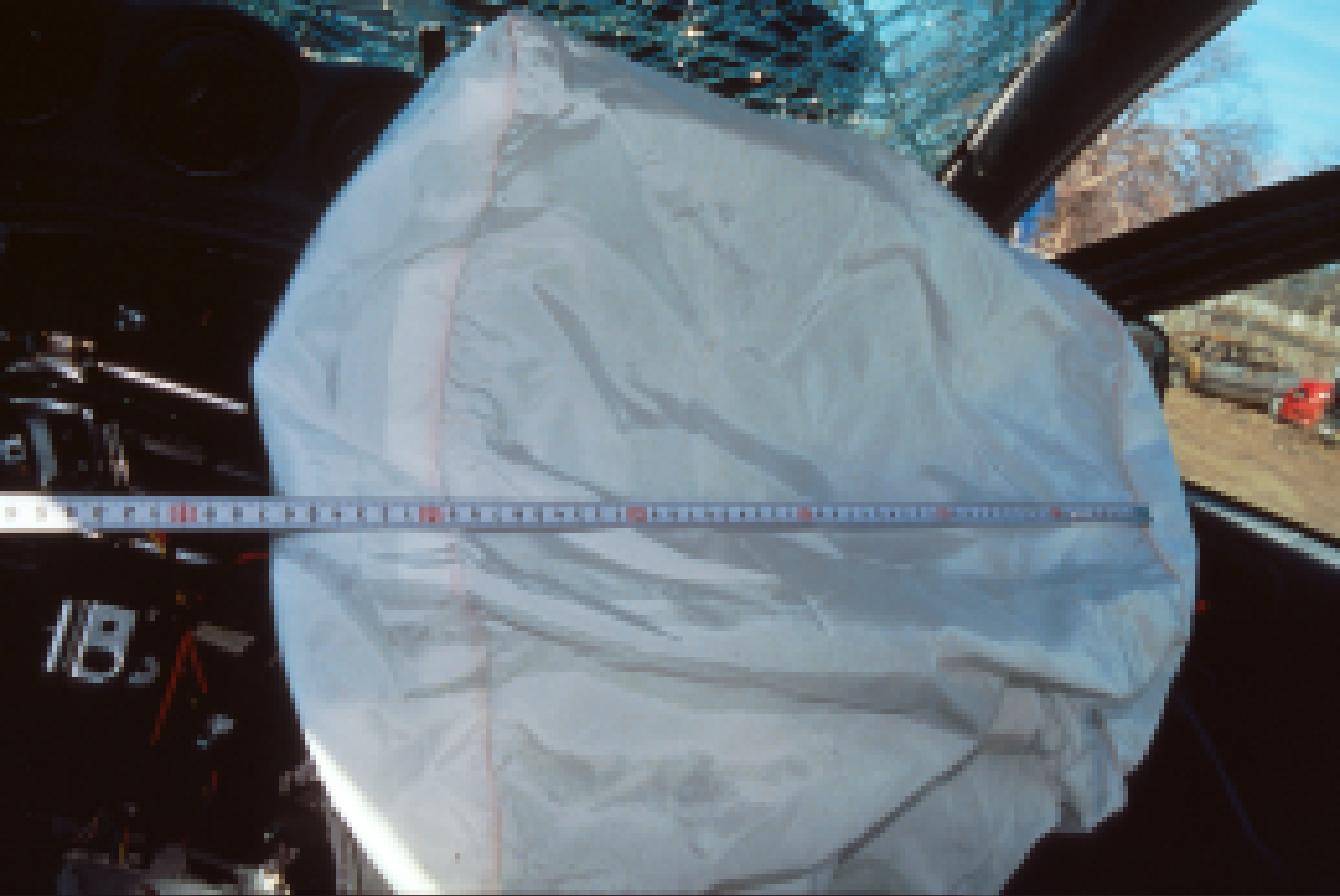
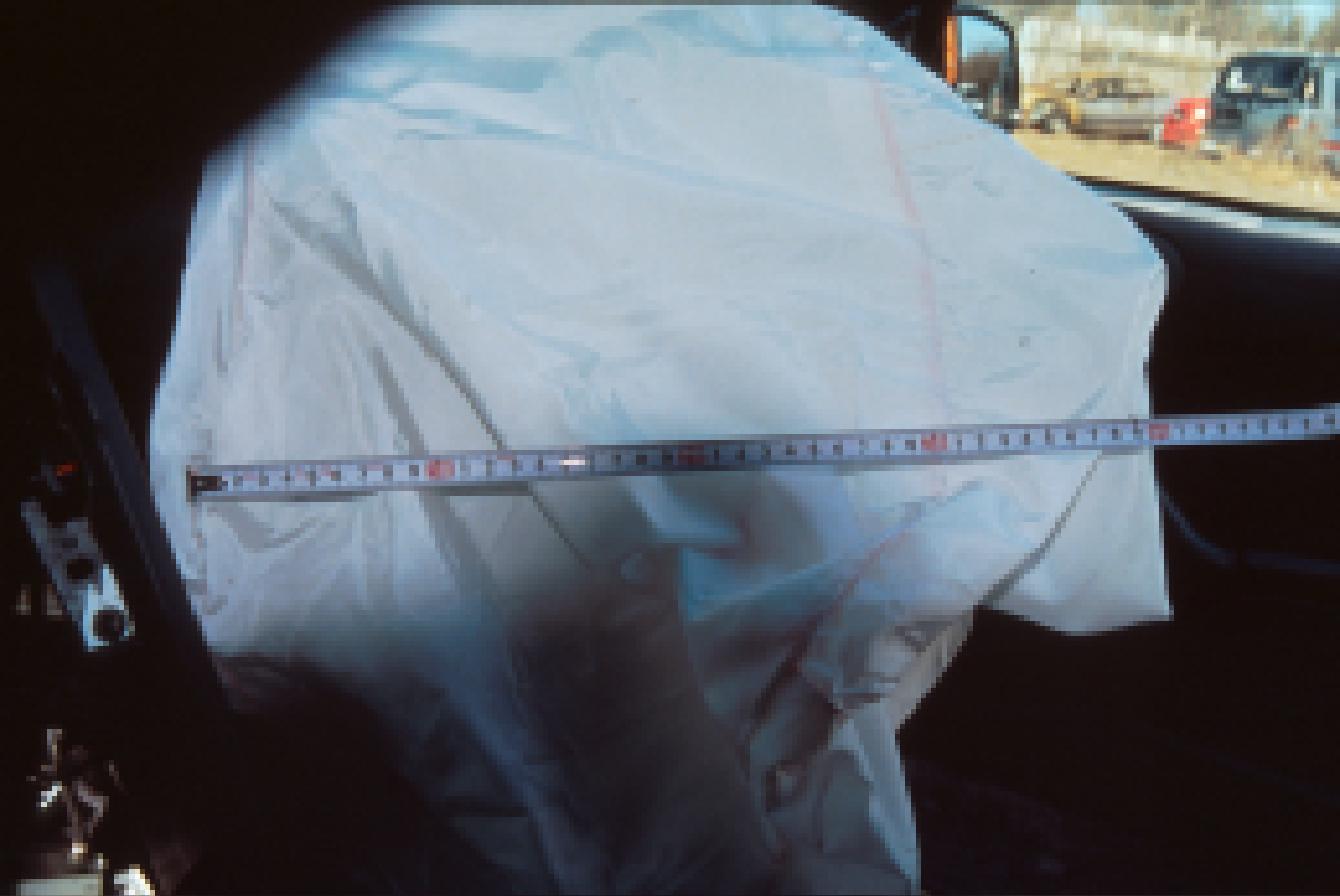
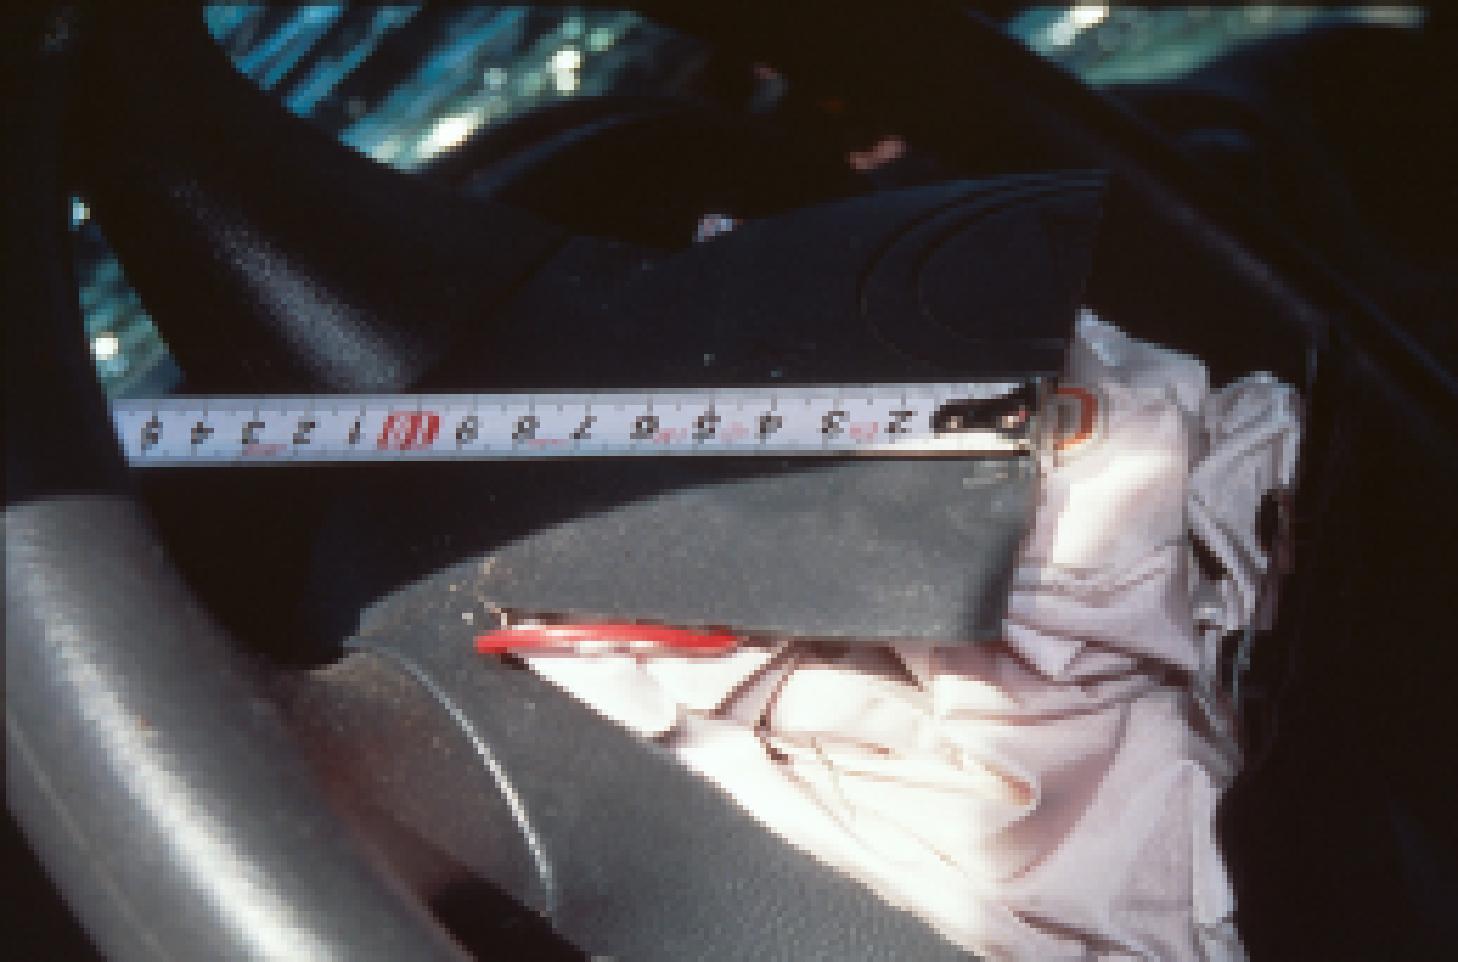
(Slides 13, 14, 15, 16, 17) This vehicle was equipped with both steering-wheel and passenger frontal-impact airbags, which deployed during the frontal impact. No damage was noted to the airbag skins or (slides 18, 19, 20, 21) to the module doors/flaps. (Slide 22) The steering-wheel rim was not deformed and there was no deformation of the steering-wheel spokes. The steering column was rotated up and to the right. (Slides 23, 24, 25) The following intrusions were noted and measured.
